# 2002 Annual Site Inspection and Monitoring Compliance Report for Uranium Mill Tailings Radiation Control Act Title II Disposal Sites

November 2002

Prepared by  
U.S. Department of Energy  
Grand Junction Office  
Grand Junction, Colorado

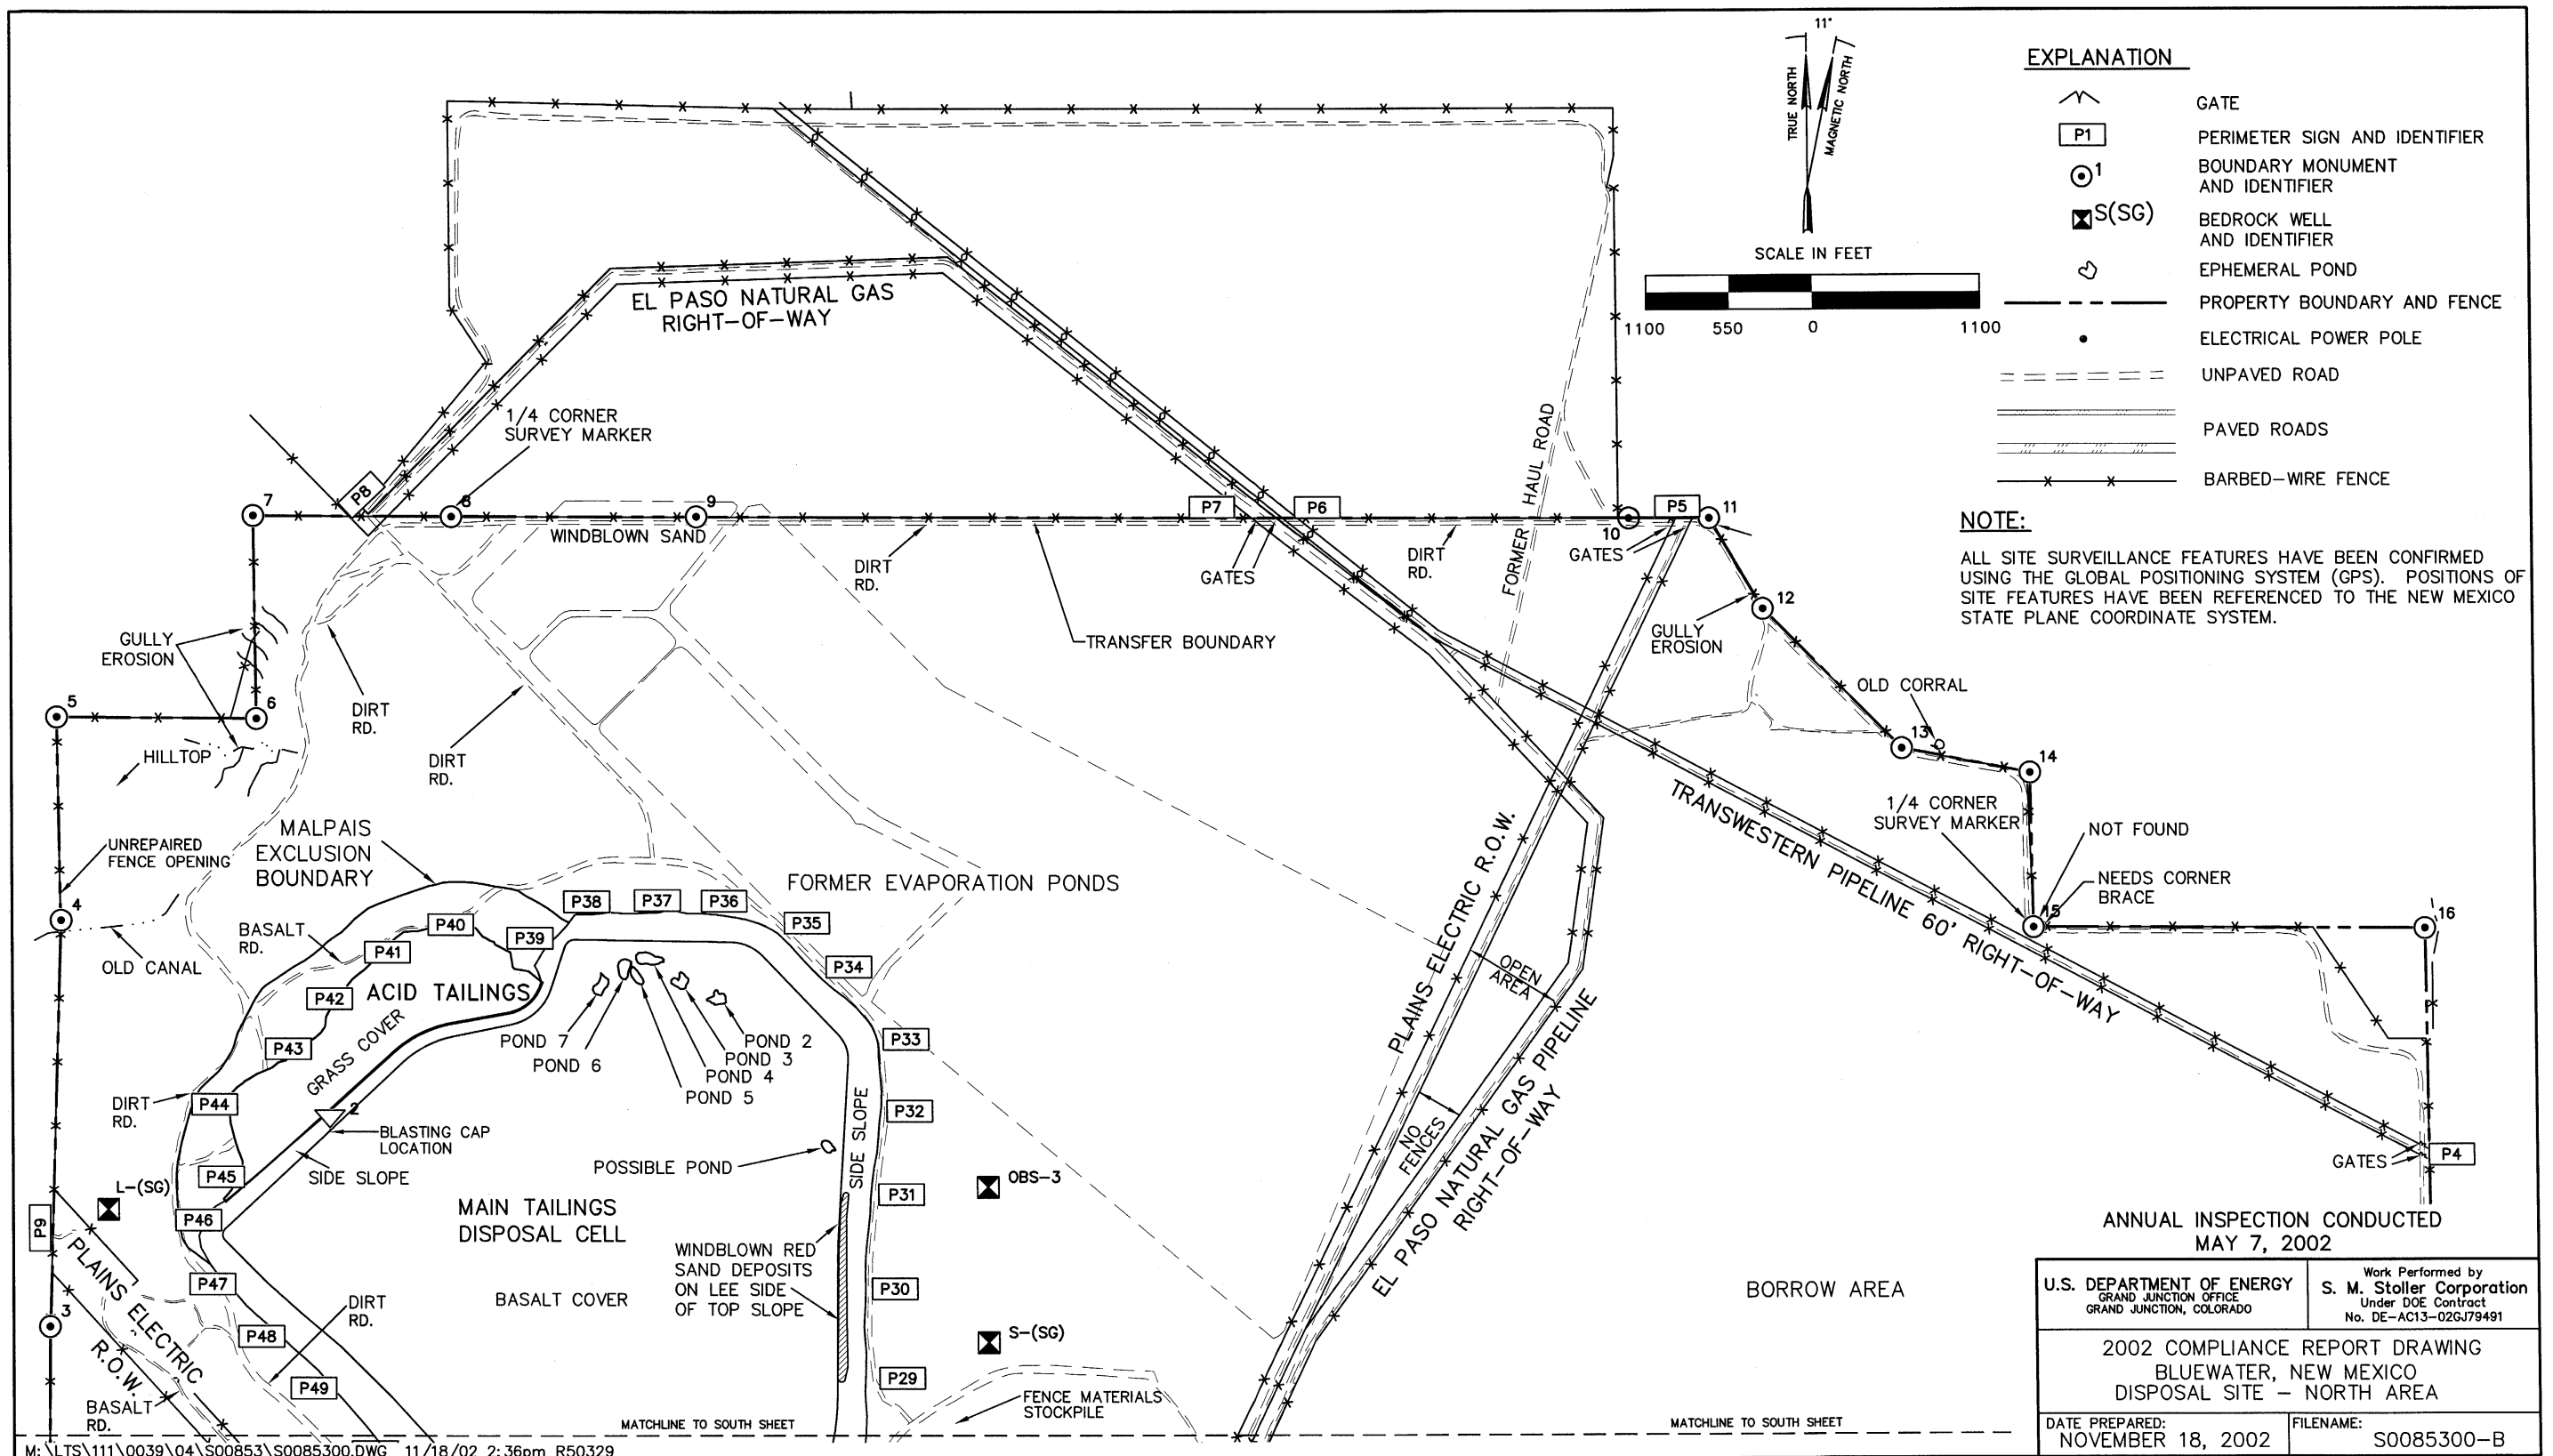
Figure 1-2. Bluewater, New Mexico, North Area, 2002

Fifty-four perimeter or warning signs, designated P1 through P52 on [Figures 1–1](#) and [1–2](#) (including perimeter signs P2A, P2B, P9A, and P9B), are posted at access points along right-of-way intersections with the site boundary and around the main and carbonate tailings disposal cells. At the Bluewater site, all signs are identical and convey the information typically conveyed on entrance signs at other Long-Term Surveillance and Maintenance (LTSM) Program sites. Perimeter sign P1, located at the access gate, was missing; inspectors replaced P1 (PL–1).

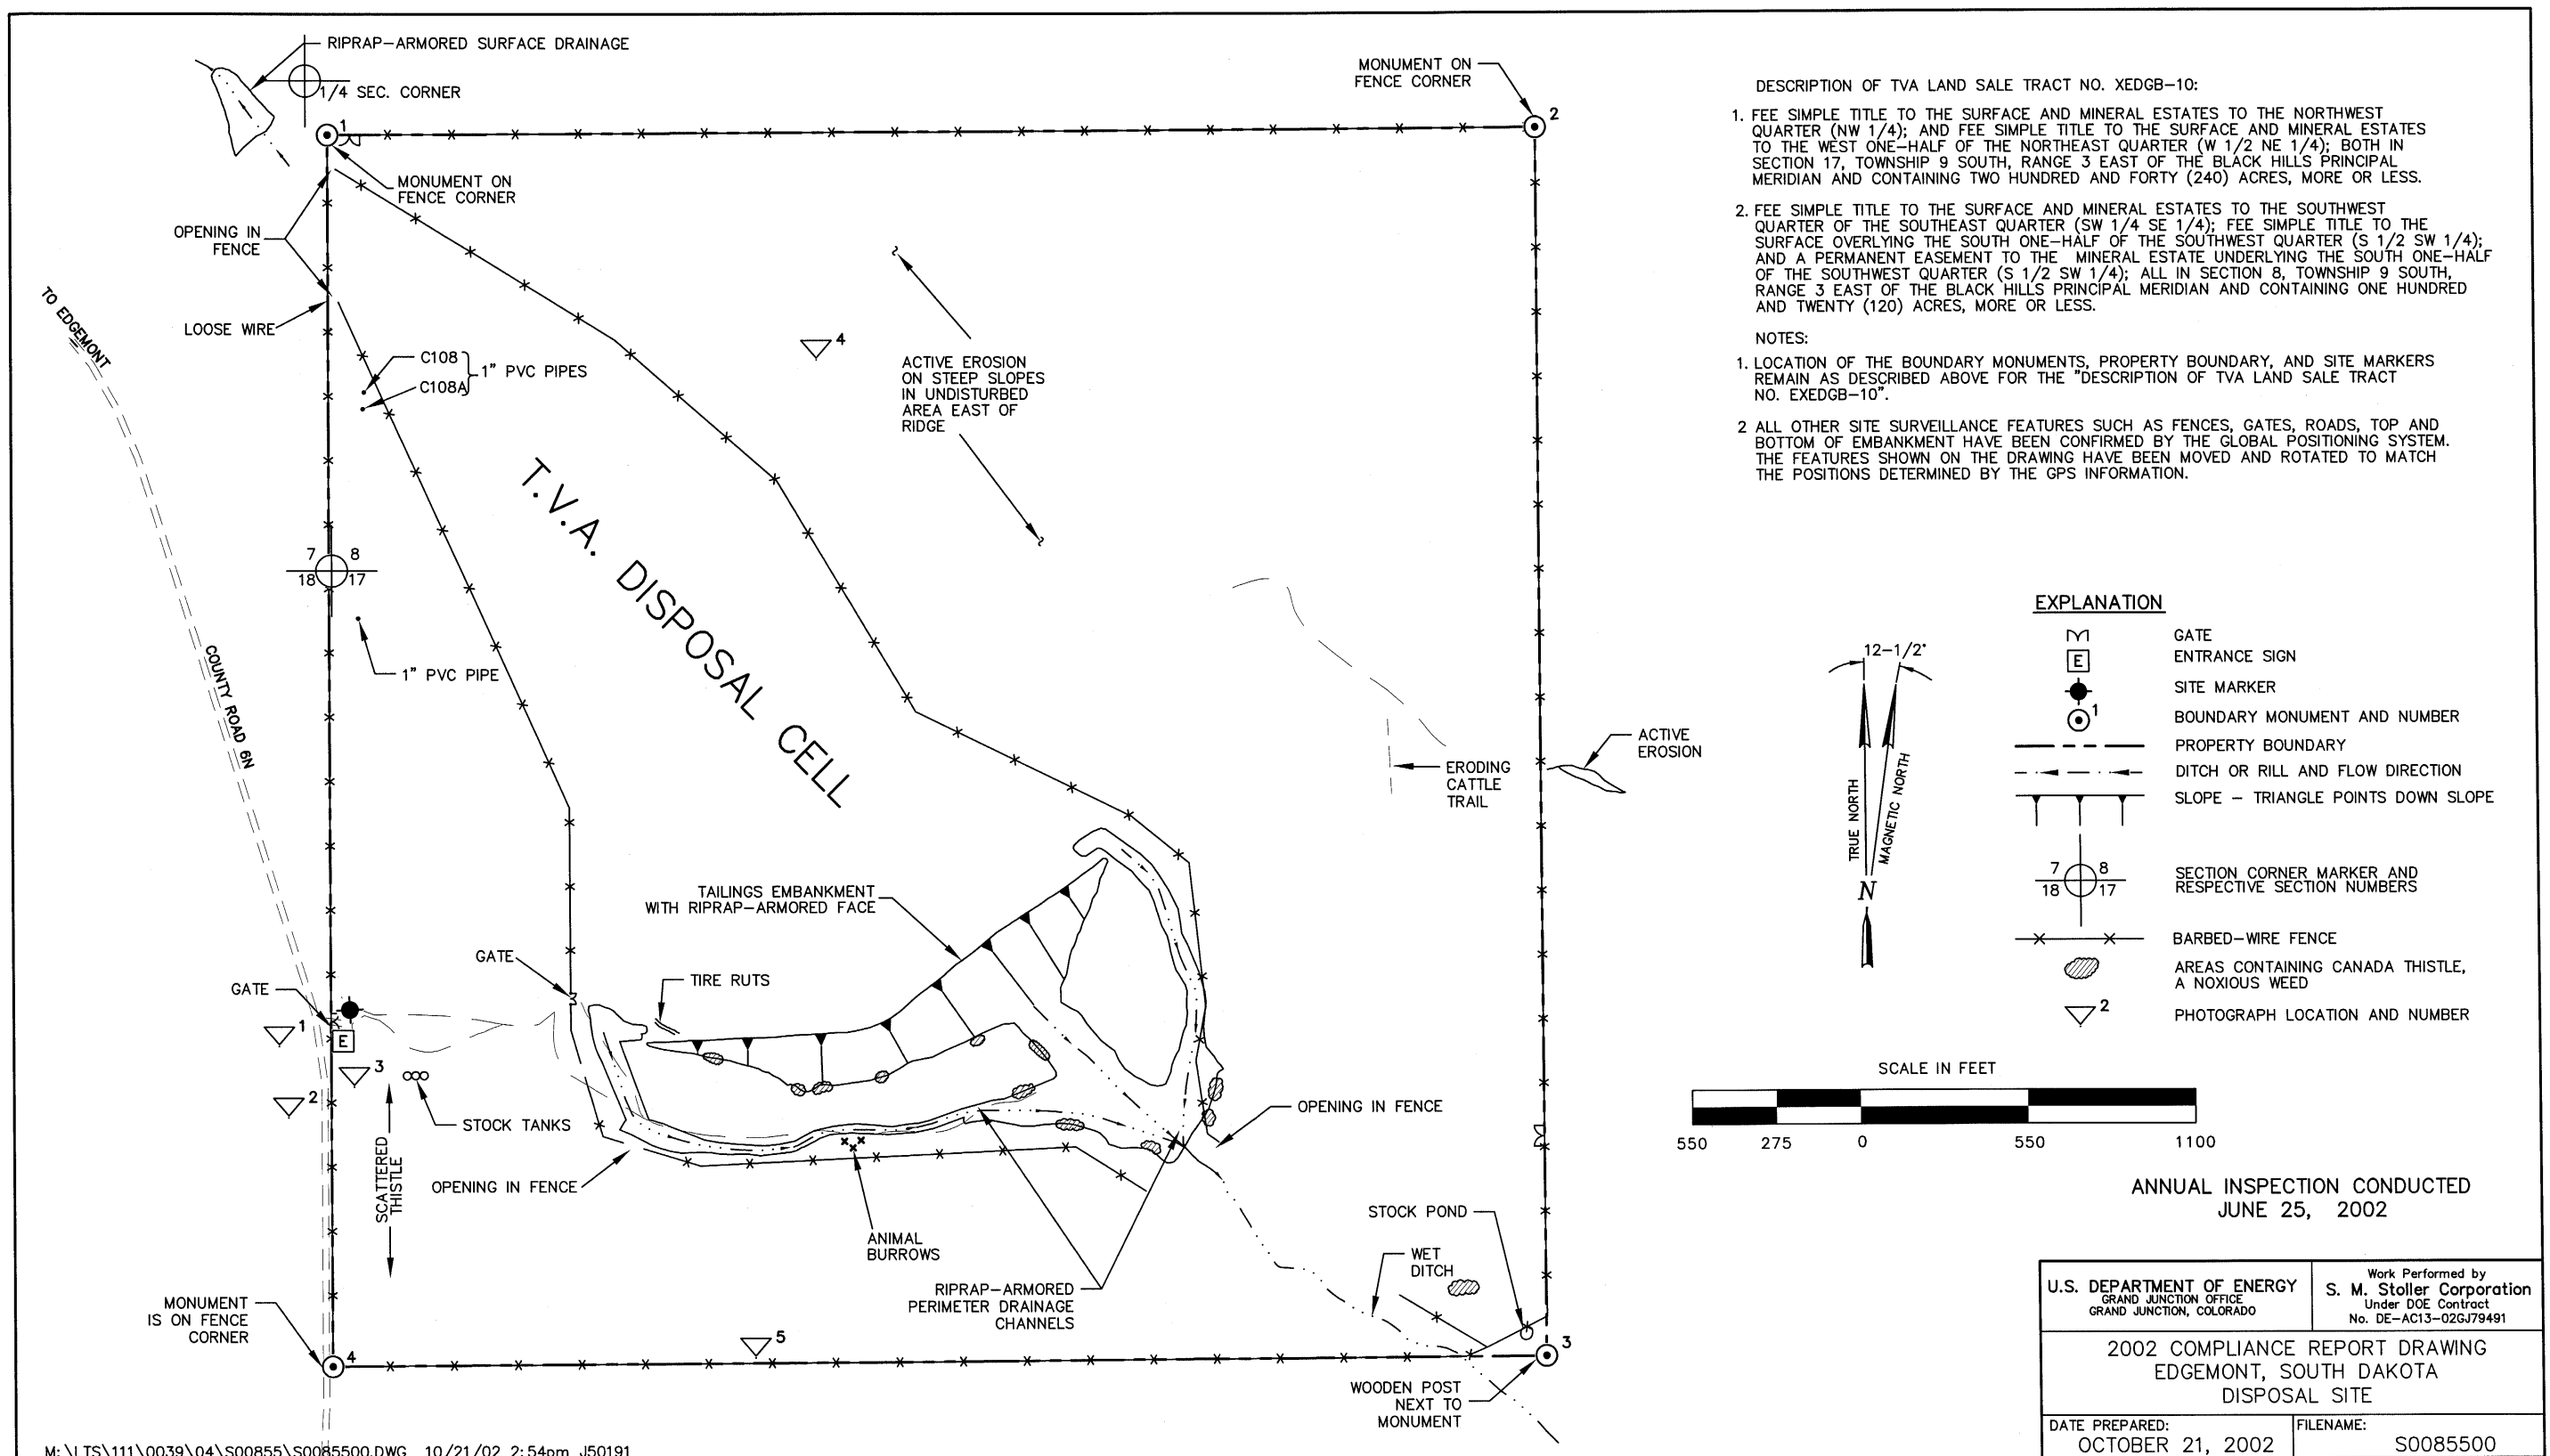
Figure 2-1. Edgemont, South Dakota, 2002

The tailings dam face is covered with riprap and represents the steepest slope on site. The slope is stable and the riprap shows no signs of degradation. Scattered plants, mostly grass, grow in the riprap (PL-5A, PL-5B, and PL-5C). These plants do not pose an immediate threat to stability or function of this structure. The plant density has not increased over the last few years. Plant density in the riprap dam face will continue to be evaluated during future inspections.

Water was present in the drainage outlet below the tailings embankment, as reported previously. The drainage outlet is the lowest point on site and most of the precipitation that falls on the site exits there. The amount of water present was significantly less than that observed during previous inspections. The lack of moisture is due to drought being experienced by the region during the spring and early summer seasons of 2002. Wetland vegetation has established in the drainage outlet below the dam.

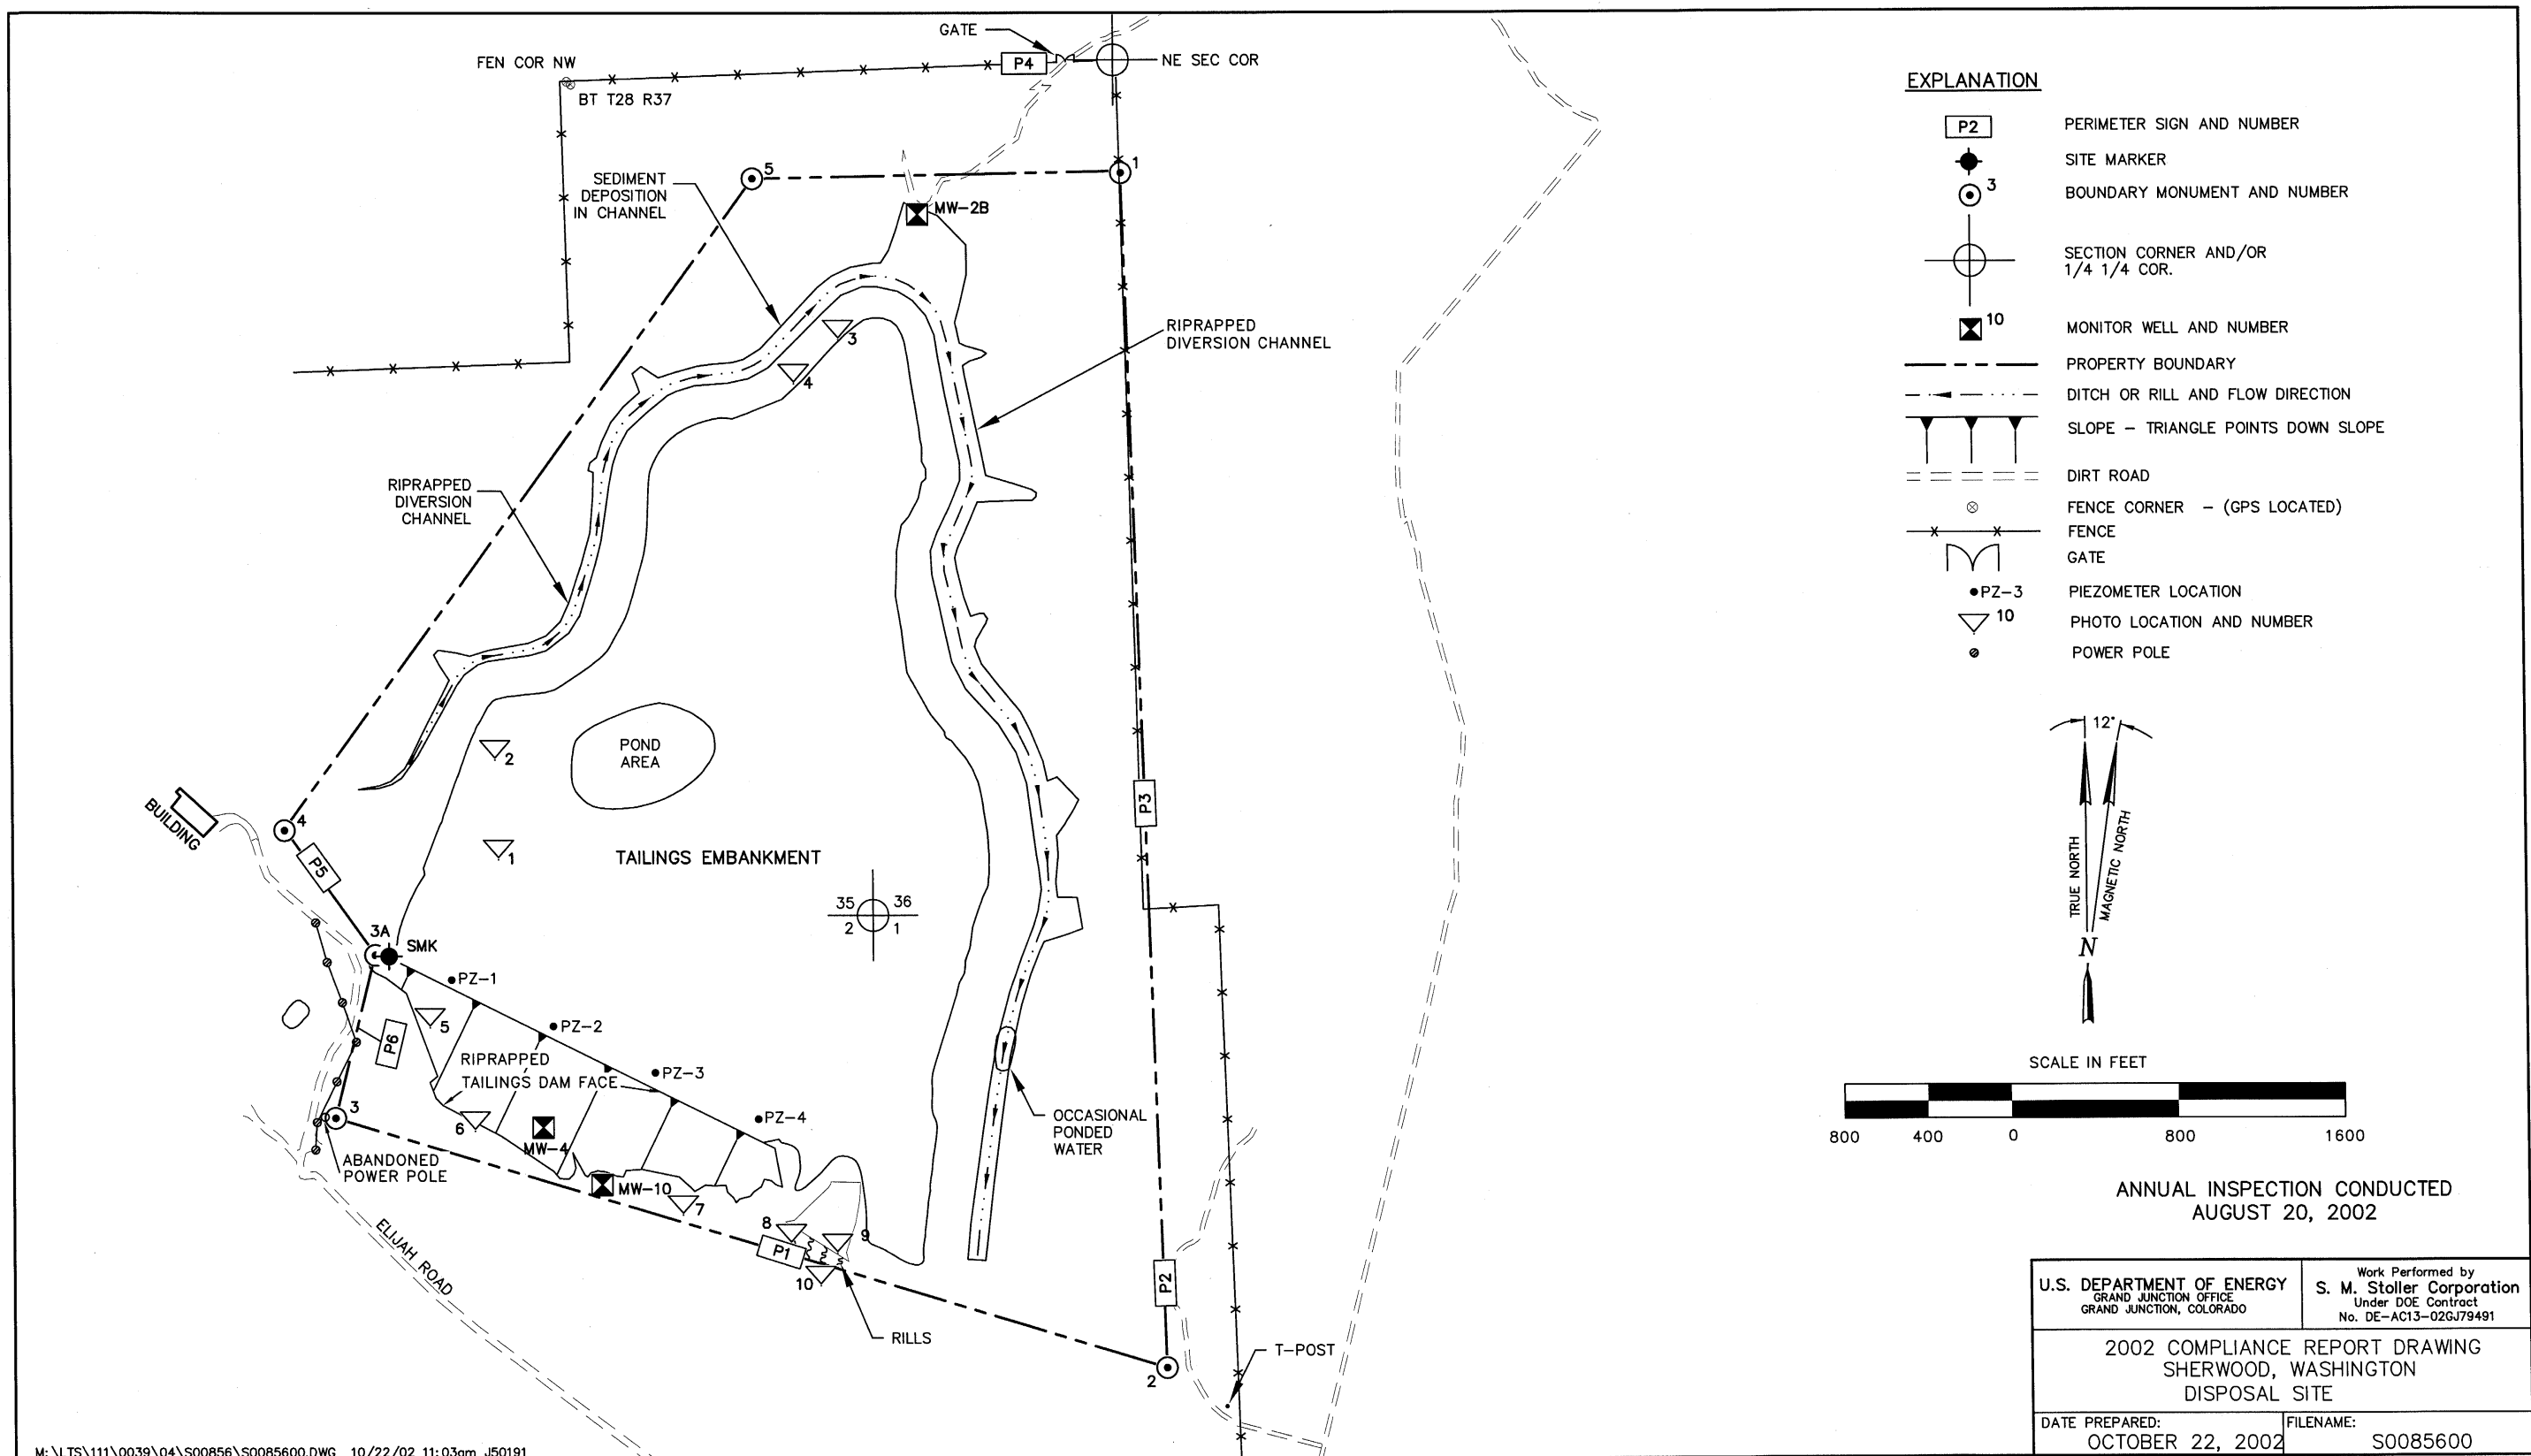
Figure 3-1. Sherwood, Washington, 2002

Inspectors walked the length of the diversion channel. Volunteer plant intrusion within the diversion channel is evident in most areas of the channel; however, this intrusion is not expected to interfere with the channel's design function. Rock condition is good and is the same as observed during earlier inspections. Sediment deposition is evident in places on the west side of the diversion channel (PL-3 and PL-4), but currently does not interfere with the channel's design function. The degree of sediment deposition should be noted during future inspections although it is not expected to increase to the degree that it could become a maintenance issue. At times, standing water has been observed in the channel along the east side of the impoundment (see Figure 3-1); this area was dry during the 2002 inspection.
